# ATTENTION CORTLAND DEVELOPERS

## Important Information Enclosed Regarding: Memory, Sound & Compatibility

## SOUND GLU FIX

(Green pre-productions boards only)

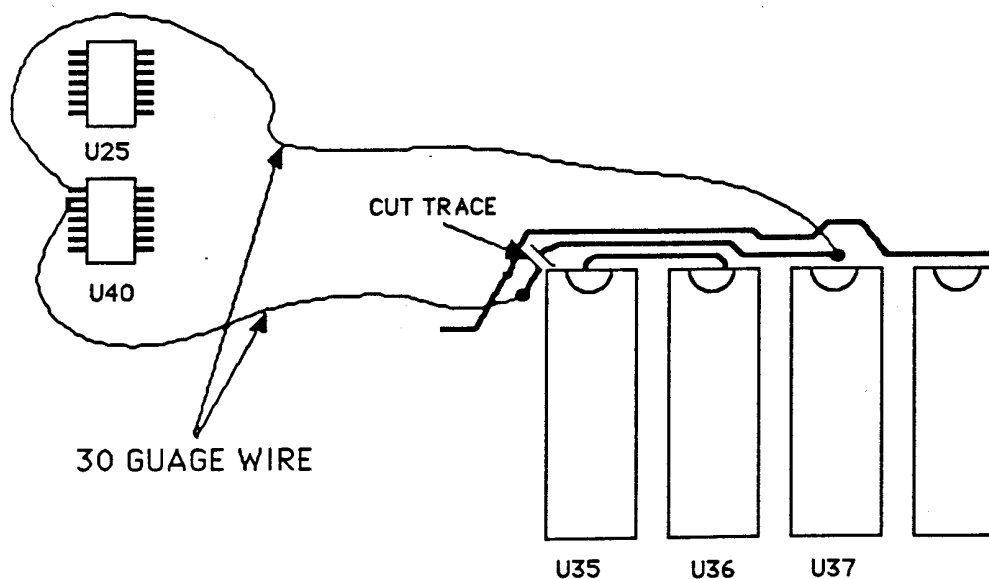
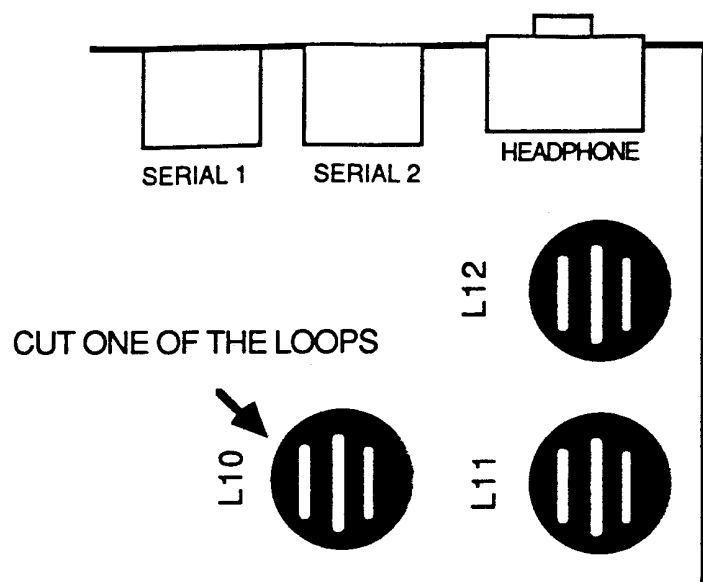
The following circuit modification fixes a timing problem with the sound glu, and a board layout error. The symptoms of the timing problem show up as loss of data in the sound memory. This can cause a clicking sound or an oscillator to stop unexpectedly. To correct this problem follow the instructions below.

1. Be sure you are competent to cut traces and solder wire, if you are not, find someone who is.
2. With the board still in the case, carefully cut the trace just above pin 1 of U35.
3. Solder a wire to pin 1 of U40 and connect the other end to the feed-through just above U37.
4. Solder a wire to pins 2 and 3 of U40 and connect the other end to the feed-through next to pin 1 of U35.
5. Cut one of the wire loops at the top of inductor L10.
